A 10-year follow-up of autogenous osteochondral transplantation combined with medial opening-wedge high tibial osteotomy for large medial femoral condyle chondral delamination: A case report

Takuma Kaibara, MD., PhD¹[®], Eiji Kondo, MD., PhD²[®], Akihito Sotome, MD., PhD¹[®], Takaaki Fukui, MD., PhD³[®], Masatake Matsuoka, MD., PhD¹[®], Koji Iwasaki, MD., PhD²[®], Tomohiro Onodera, MD., PhD¹[®], Daisuke Momma, MD., PhD²[®], Norimasa Iwasaki, MD., PhD¹[®]

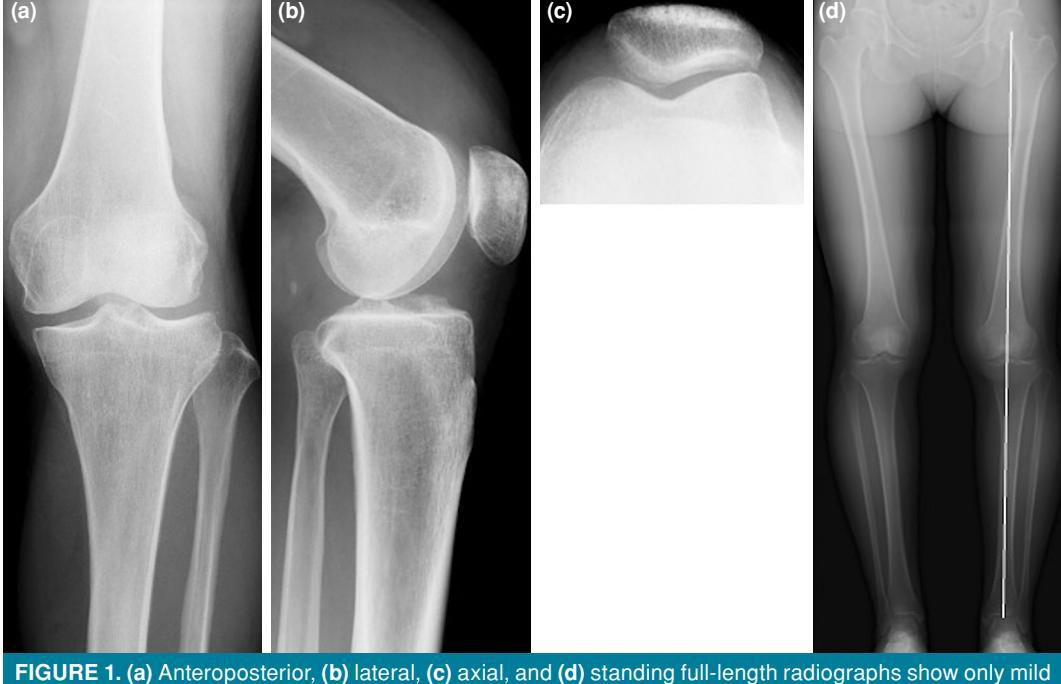
FIGURE 1. (a) Anteroposterior, (b) lateral, (c) axial, and (d) standing full-length radiographs show only mild degenerative changes. The white line represents the mechanical axis.

She presented to our affiliate hospital approximately one year after the initial injury. Her physical examination revealed effusion without any signs of instability in the left knee. Tenderness was noted at the medial joint space. Pain limited the range of knee flexion to 140°. Plain radiographs showed only mild degenerative changes consistent with Kellgren-Lawrence Grade 1 (Figure 1). A 0.2-Tesla magnetic resonance imaging (MRI) revealed fluid effusion and a large bone marrow lesion in the MFC; however, chondral delamination was not detected (Figure 2). No meniscal or ligamentous lesions were identified.

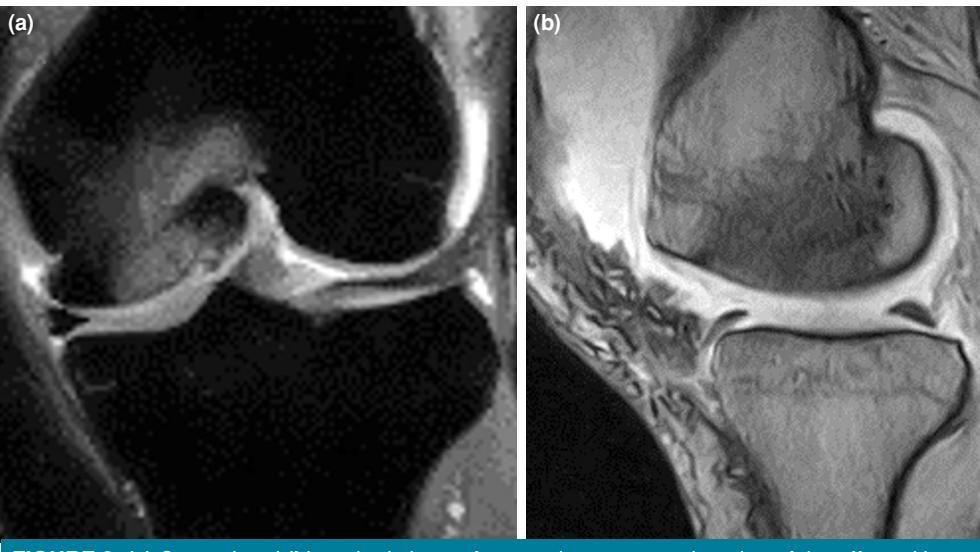
FIGURE 2. (a) Coronal and **(b)** sagittal views of magnetic resonance imaging of the affected knee show fluid effusion and a large bone marrow lesion in the medial femoral condyle. No evidence of chondral delamination is observed.

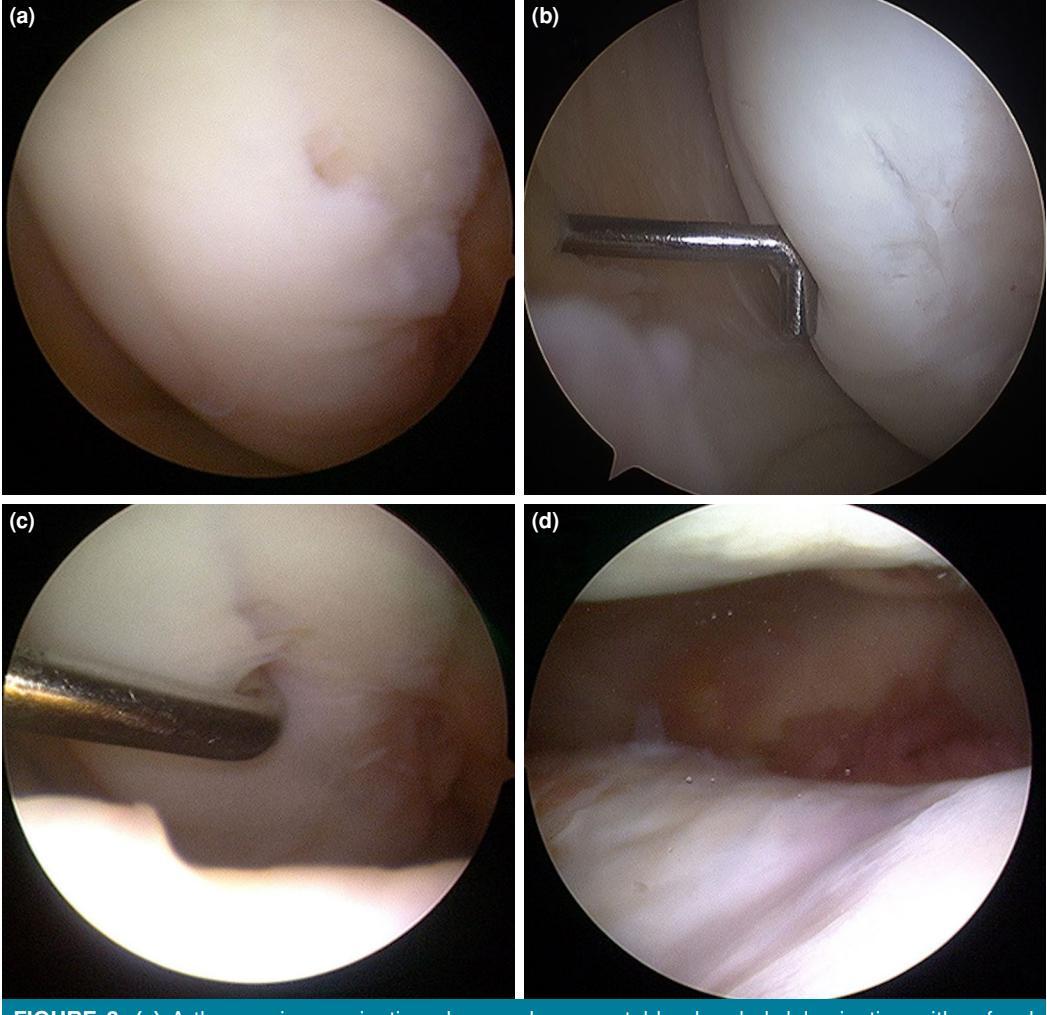
FIGURE 3. (a) Arthroscopic examination shows a large unstable chondral delamination with a focal cleavage lesion in the medial femoral condyle. **(b)** The probe demonstrates softening and wavy delaminated cartilage and **(c)** is introduced through the focal fissure into the space between the delaminated cartilage and subchondral bone. **(d)** An ICRS grade 2 cartilage lesion is observed at the femoral trochlea.

undulation of the articular surface of the MFC. A focal fissure was identified at the lateral aspect of the MFC, where the cartilage was detached from the underlying subchondral bone, although the delaminated cartilage remained attached to the surrounding normal cartilage at its periphery (Figure 3a-c). This delamination was located primarily on the weight-bearing surface of the mid-portion of the MFC. The anterior portion of the lesion corresponded to the distal portion of the femoral trochlea that contacts the patella during deep flexion. There was International Cartilage Repair Society (ICRS) Classification Grade 2 cartilage damage at the femoral trochlea (Figure 3d). No meniscal or ligamentous injuries were observed. Based on the arthroscopic findings, the patient was diagnosed with Grade 3 chondral delamination with a focal cleavage lesion of the MFC (Figure 3c), according to the classification system proposed by Konan et al.^[11]

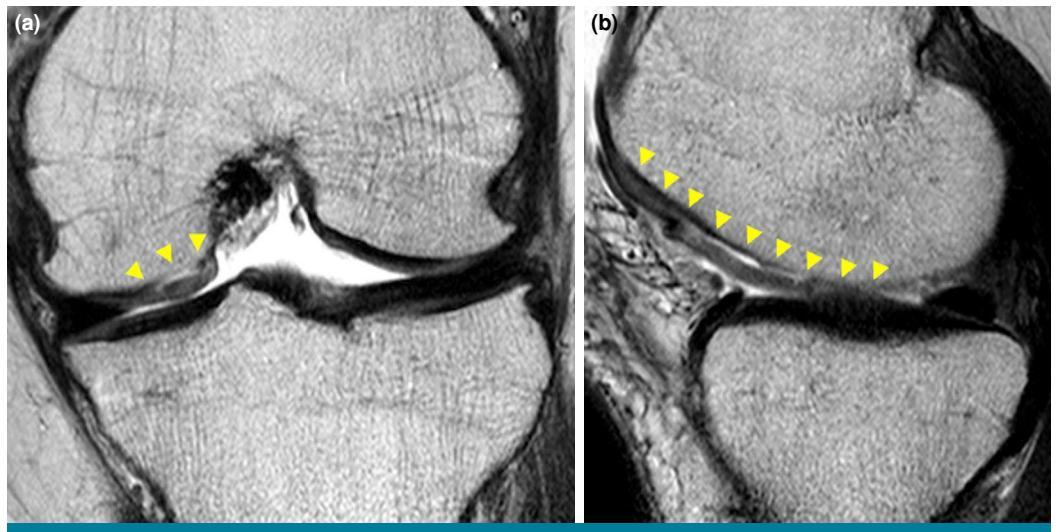
FIGURE 4. (a) Coronal and **(b)** sagittal views of T2-weighted magnetic resonance imaging show a linear hyperintense area between the articular cartilage and subchondral bone at the medial femoral condyle. Yellow arrows indicate the area of chondral delamination.

The patient was subsequently referred to our hospital two weeks after initial arthroscopic examination. Physical examination revealed leftside protective limping, knee joint swelling, and limited range of knee motion (extension -10° to flexion 140°). The assessment for generalized joint hypermobility using the Carter and Wilkinson method revealed no evidence of hypermobility. Radiographs demonstrated neutral alignment of the affected lower limb (Figure 1a, c). Alignment measurements included the hip-knee-ankle (HKA) angle –2.2°; anatomical femorotibial angle (FTA) 177.0°; medial proximal tibial angle (MPTA) 86.3°; mechanical axis of the lower limb 41.5% (percentage of tibial plateau width from the medial edge); posterior tibial slope (PTS) 7.3°; Insall-Salvati (I-S) ratio 0.97; Caton-Deschamps (C-D) index 0.89; and other alignment parameters are presented in Table I. The HKA angle was measured as positive in valgus knees and negative in varus knees. A 3.0-Tesla MRI revealed fluid infiltration between the cartilage and subchondral bone in the MFC, indicating chondral delamination approximately 20×40 mm in size (Figure 4).

High-resolution MRI has been recognized as a valuable tool for diagnosing chondral delamination, capable of detecting fluid signals at the cartilage-subchondral bone interface.^[2,10,14] In this case, while initial low-resolution MRI failed to detect the lesion, subsequent high-resolution imaging demonstrated the delamination. However, the diagnostic sensitivity of MRI remains limited, high-resolution techniques.^[2,10,14] with even Therefore, when chondral delamination is suspected based on clinical history and injury mechanisms, diagnostic arthroscopy should be considered. Direct arthroscopic visualization and probing enable detailed assessment of cartilage abnormalities that may not be apparent on imaging studies. Early detection and appropriate characterization of these lesions are crucial for determining optimal treatment strategies and preventing progression to full-thickness cartilage defects.

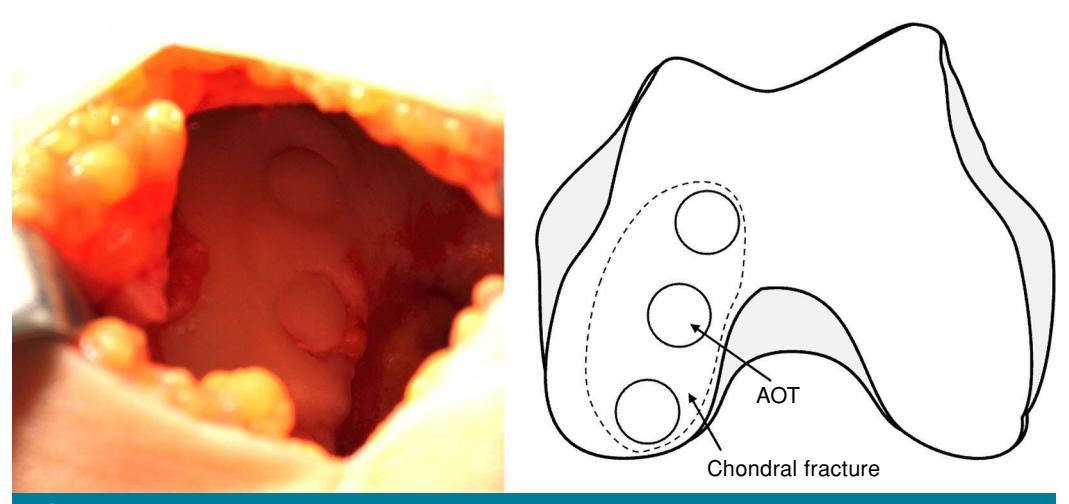
FIGURE 5. (a) Intraoperative photograph and schematic illustration of autogenous osteochondral transplantation for delaminated cartilage fixation. Gross view shows the medial femoral condyle with three cylindrical autogenous osteochondral grafts fixing the delaminated cartilage. **(b)** Schematic illustration demonstrates delaminated chondral fixation with autogenous osteochondral transplantations. The dotted line indicates the delaminated chondral lesion. AOT: Autogenous osteochondral transplantation.

The patient was positioned supine, and an arthrotomy was conducted via a parapatellar approach over the MFC. The subchondral bone beneath the delaminated cartilage was slightly sclerotic. Initially, bone marrow stimulation was carried out by perforating subchondral bone through delaminated cartilage using a 1.5-mm Kirschner wire (K-wire). Next, three osteochondral autografts were transferred to fix the unstable delaminated cartilage using the 6.0-mm OATS system (Arthrex, Naples, FL, USA) (Figure 5). Donor grafts were harvested from the lateral edge of the femoral trochlea.

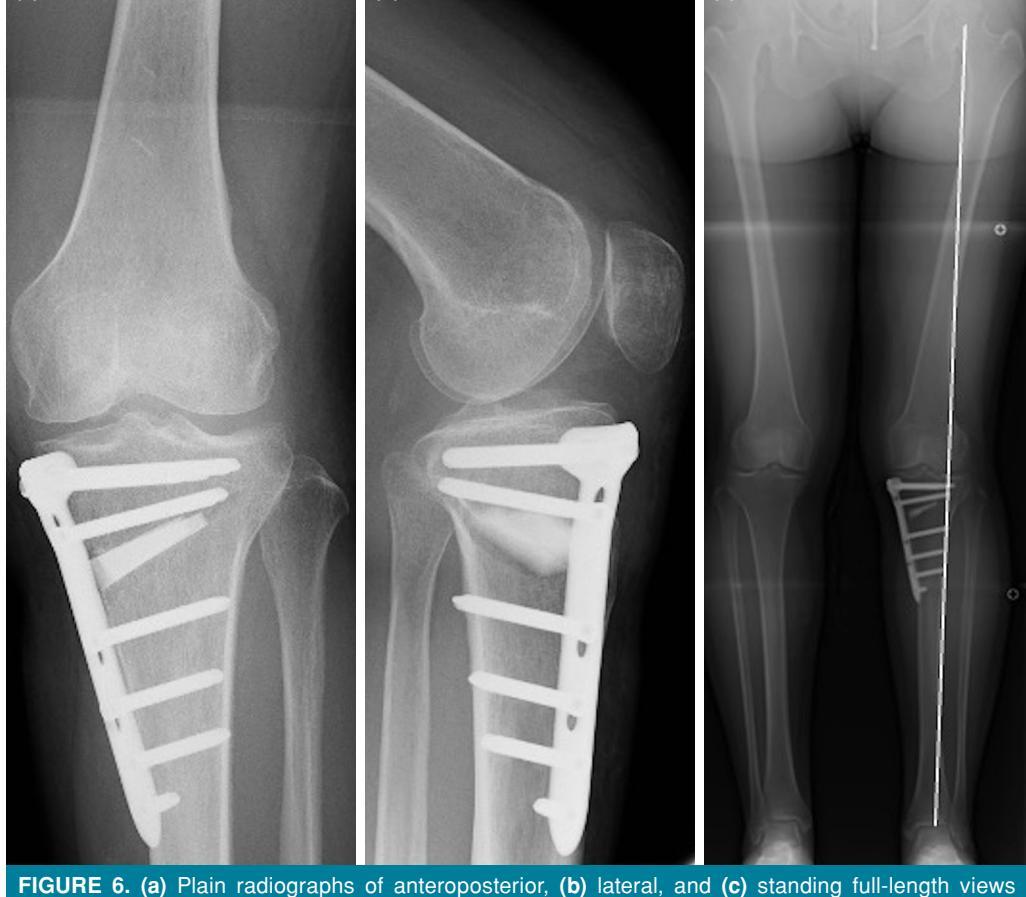
immediately after chondral fixation and medial opening high tibial osteotomy demonstrate the knee corrected to valgus position, with patella baja and increased posterior tibial slope observed. The white line represents the mechanical axis.

medial collateral ligament was released completely. Using a parallel guide system, three pairs of guidewires were placed from the medial tibia, starting 40 mm below the joint line and directed toward the proximal tibiofibular joint. Following the biplanar ascending osteotomy of the tibial tubercle, the osteotomy site was opened gradually with a spreader (Olympus Terumo Biomaterials, Tokyo, Japan) according to the preoperative plan. The osteotomy gap was filled with two wedge-shaped β -tricalcium phosphate spacers (Osferion 60, Olympus Terumo Biomaterials). The osteotomy was secured with a locking plate system (TomoFix, DePuy Synthes, West Chester, PA) (Figure 6).

After surgery, the knee was corrected to valgus and postoperative HKA angle, FTA, MPTA, and mechanical axis were 5.1°, 171.0°, 92.5°, and 72.9%, respectively (Table I, Figure 6). The mechanical axis exceeded our target of 65%, indicating unintentional overcorrection. Regarding the parameters influencing the patellofemoral (PF) joint, the PTS, I-S ratio, and C-D index were 9.7°, 0.76, and 0.67, respectively (Table I).

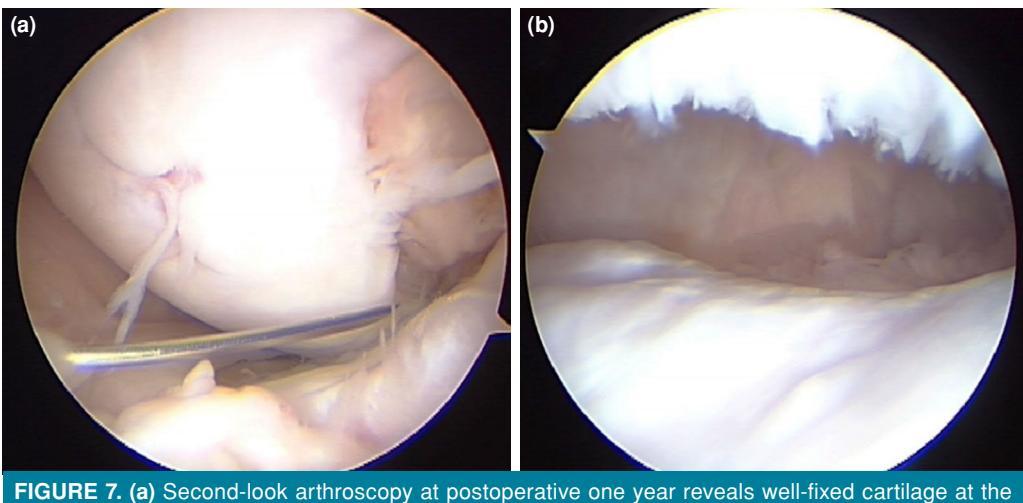
FIGURE 7. (a) Second-look arthroscopy at postoperative one year reveals well-fixed cartilage at the location of chondral delamination. (b) Evidence of exacerbated cartilage degeneration is observed in the patellofemoral joint.

patients desire to remove the metal materials after surgery due to religious reasons and cultural factors, which include sitting on tatami flooring. At the site of previous delamination and AOT fixation, the arthroscopic examination revealed mild cartilage surface fibrillation, although the repaired cartilage demonstrated native articular cartilage-like hardness and remained well-fixed to the underlying bone with no signs of recurrent delamination (Figure 7). In addition, the fibrillation of the patellar cartilage and longitudinal fissures were observed in the central portion of the femoral trochlea, graded as cartilage injury of ICRS Grade 3, which was indicative of advanced PF joint osteoarthritis. In addition, T2-weighted MRI at postoperative 24 months confirmed integration of the delaminated cartilage into the surrounding articular cartilage and subchondral bone (Figure 8).

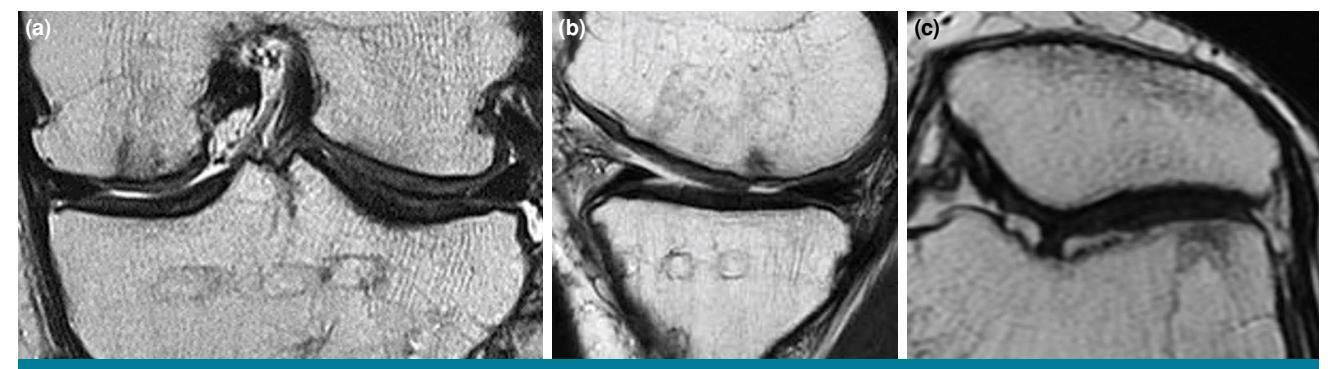
FIGURE 8. Magnetic resonance imaging of the lesion of cartilage delamination at 24 months. (a) Coronal, (b) sagittal, and (c) axial views demonstrate integration of the delaminated cartilage into the surrounding articular cartilage and subchondral bone.

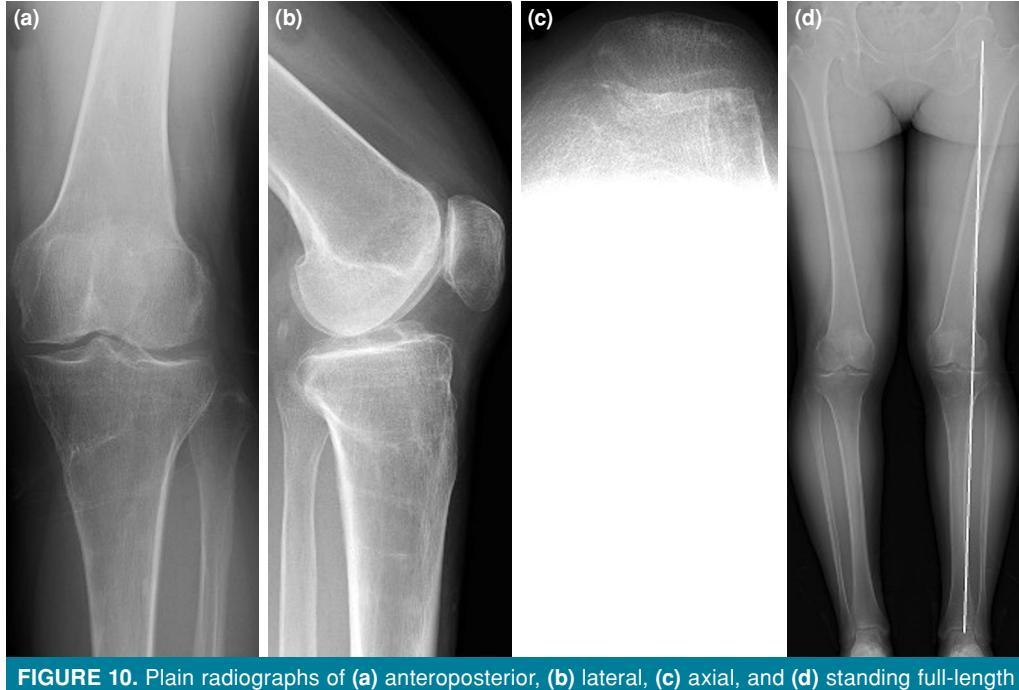
FIGURE 10. Plain radiographs of (a) anteroposterior, (b) lateral, (c) axial, and (d) standing full-length images at 10 years after chondral fixation and medial opening high tibial osteotomy demonstrate progression of femorotibial and patellofemoral osteoarthritis. The white line represents the mechanical axis.

activities (Tegner activity score: level 6) such as running, cycling, and skiing. Both the JOA and Lysholm scores reached 100 points, and the KOOS remained high (Table II). Plain radiographs revealed no loss of correction. However, the radiological stage of knee osteoarthritis progressed from Grade 1 to Grade 2 in the femorotibial joint according to the Kellgren-Lawrence grading system, and significant progression of osteoarthritic changes was observed in the PF joint (Figure 10). An MRI obtained at the 10-year follow-up detected thinning of the cartilage at the lesion site and PF joint, while the lateral femorotibial compartment

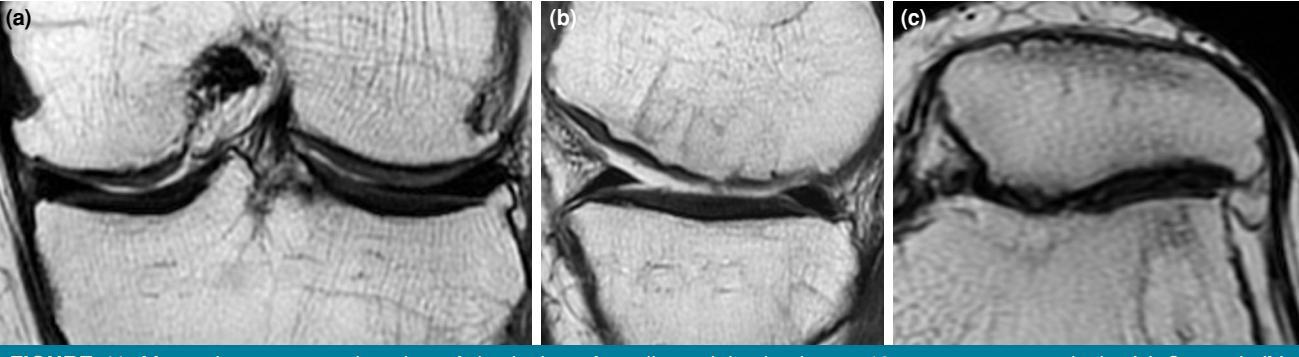
FIGURE 11. Magnetic resonance imaging of the lesion of cartilage delamination at 10 years postoperatively. (a) Coronal, (b) sagittal, and (c) axial views demonstrate cartilage thinning at the lesion site and patellofemoral joint.

maintained normal cartilage thickness (Figure 11). A written informed consent was obtained from the patient.
